DELAWARE RIVER BASIN  
LAUREL RUN, CARBON COUNTY  
PENNSYLVANIA  
NDS ID PA. 00616  
DER ID 13-97

# PLACID LAKE DAM

PHASE I INSPECTION REPORT  
NATIONAL DAM INSPECTION PROGRAM

AUGUST 1980

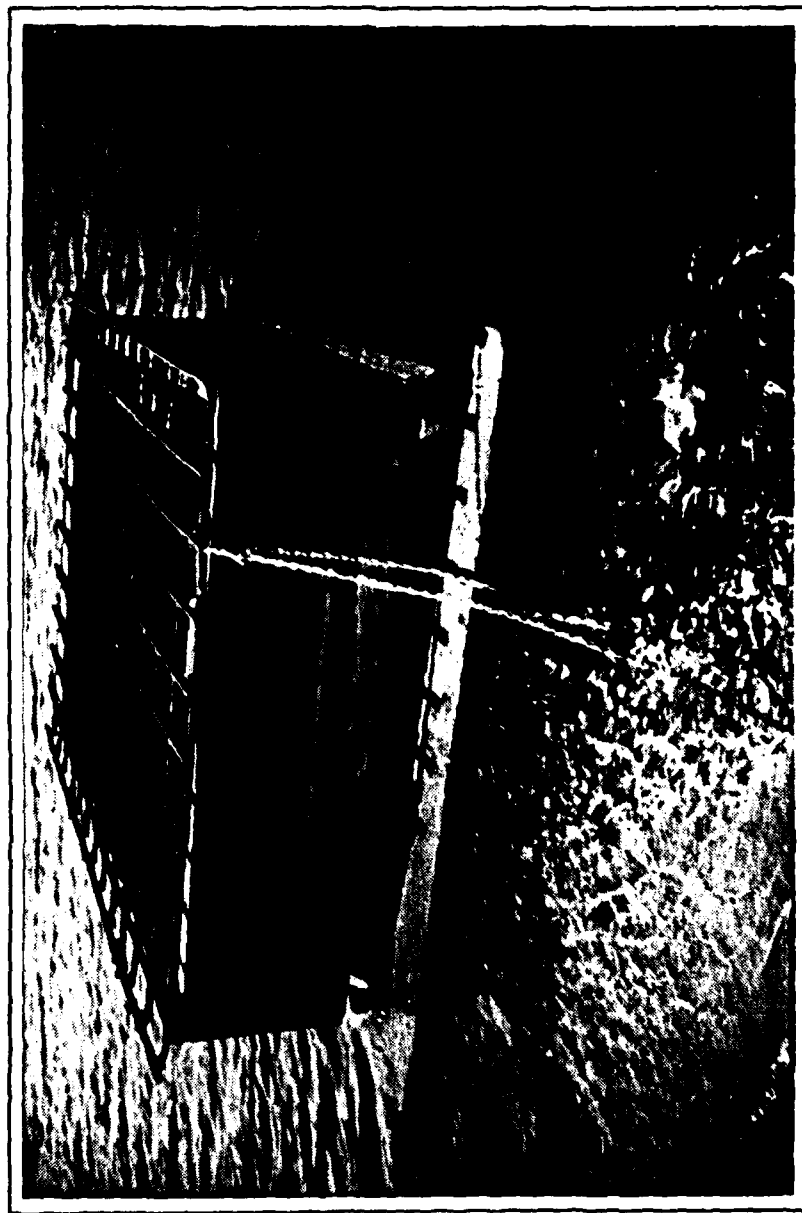
PHOTOGRAPH NO. 1

2. Spillway. A concrete box drop inlet is shown on Photograph 1. The interior of the drop spillway appears to be in good condition, with no evidence of cracking, staining or deterioration of the concrete. As shown on Photograph 1, a flashboard structure is supported on bricks above the lip of the concrete structure. Four plastic pipes on the opposite side of the flashboard structure were installed to discharge cool water from below the reservoir surface. A six inch gate valve is on the drop inlet floor on the upstream side. The valve assembly is rusted and the handle is not affixed to the valve.

c. Visual Observations. At the time of the inspection the only condition observed that would indicate a reduction in design spillway capacity is that a flashboard box structure is placed on top of the permanent drop inlet, reducing the available freeboard. Observations regarding the condition of the downstream channel, spillway and reservoir are located in Appendix A and are discussed in greater detail in Section 3.

"FLASHBOARD" BOX PROPPED UP WITH  
BRICKS, USED TO RAISE RESERVOIR  
LEVEL IN THE SUMMER.

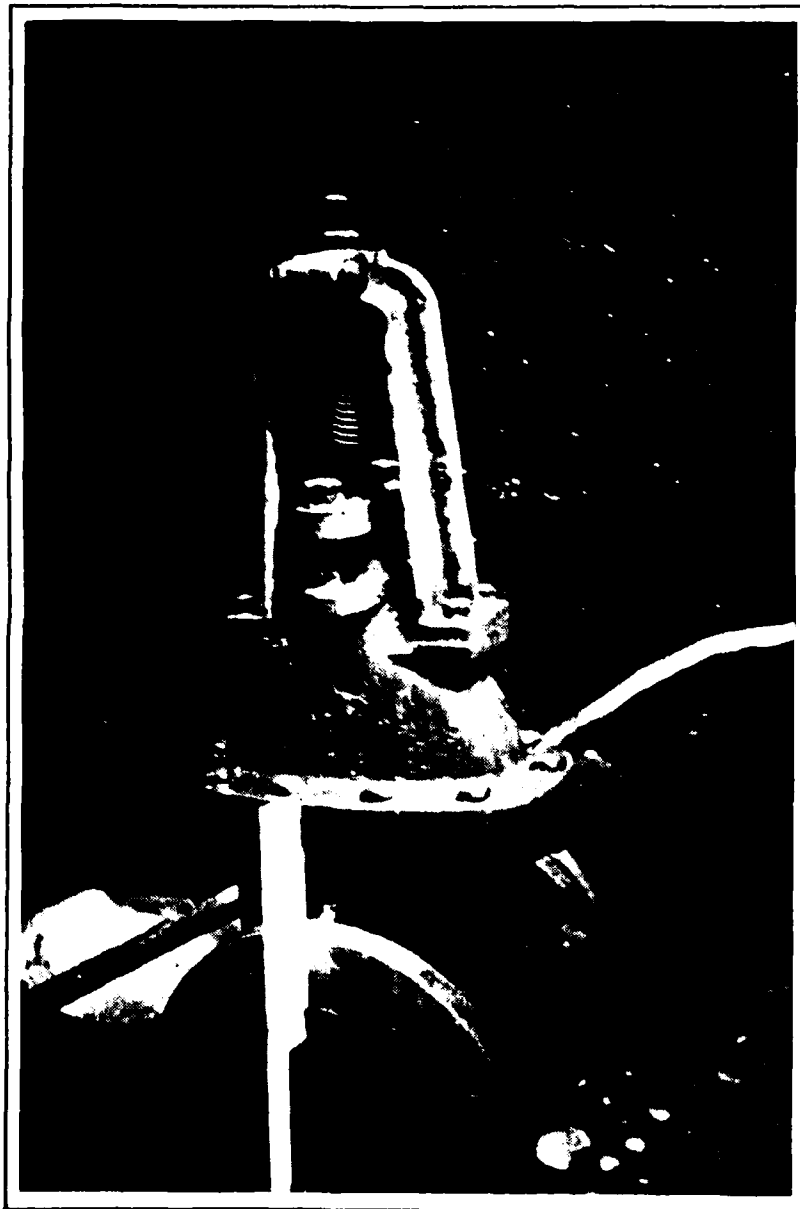
PHOTOGRAPH NO. 2

POND DRAIN GATE VALVE ON  
BASE OF RISER.

- (5) Erosion of the upstream face should be halted and the damaged embankment repaired.
- (6) The inlet sluice gate and the reservoir drain gate valve should be lubricated and exercised on a regular basis to insure their operational status.

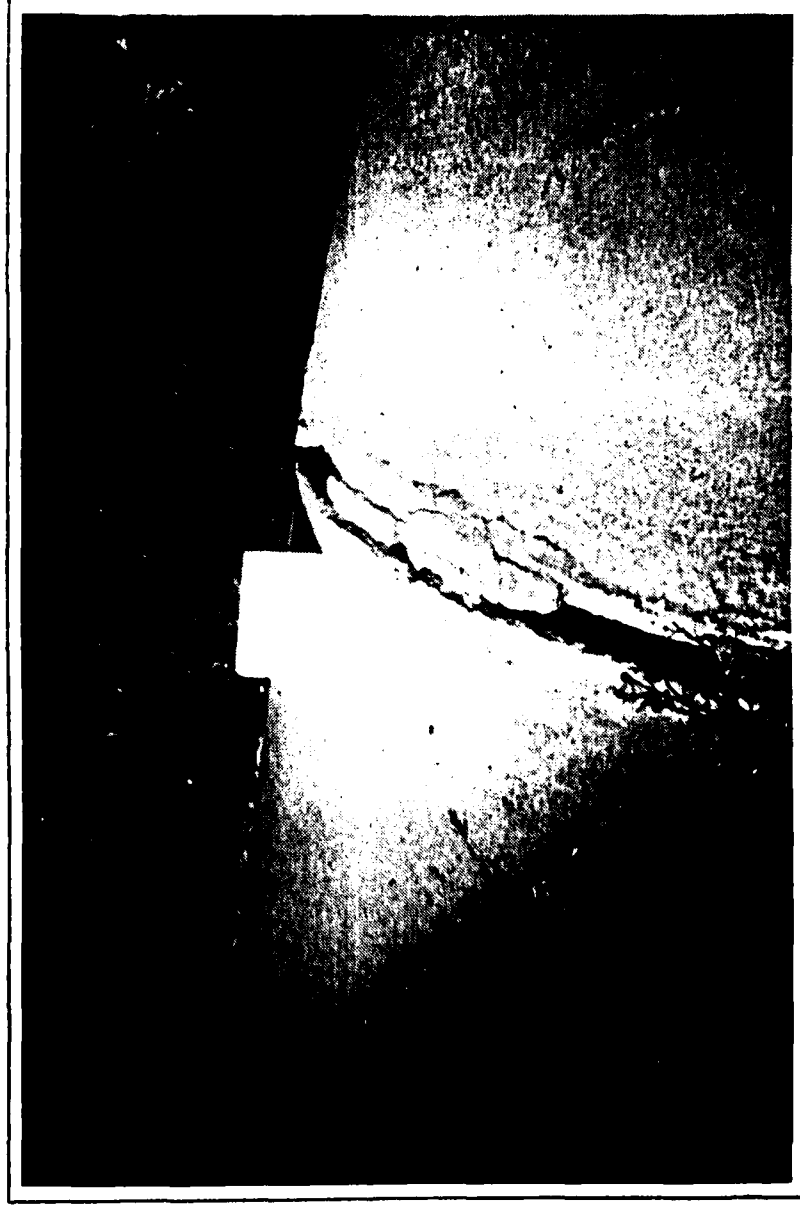
PHOTOGRAPH NO. 10

A 48 inch reinforced concrete pipe extends from the drop inlet through the dam embankment. The interior of the pipe joints showed frequent staining, leachate precipitation and missing mortar at the joints and occasionally staining or leachate precipitation through the conduit itself. There is also occasional leakage at the pipe joints. The fourth joint from the downstream end had yellow-brown sandy silt clinging to the joint, apparently soil intrusion. The second and third joints from the downstream end had cracks through the mortar 0.5 and 1.0 inches wide, apparent lateral displacement. No caulking was noted at the first joint from the downstream end, and daylight could be seen through it.

The spillway structure is in fair condition. The concrete drop inlet is in good condition. The reinforced concrete outlet pipe from the spillway is assessed to be in poor condition, consistent with the cracked mortaring and leaking of the joints, and especially the apparent displacement of two downstream sections of pipe.

The 48 inch diameter discharge pipe from the spillway was observed to have cracked and leaking joints. Such leakage at the joints, if continued, could be a potentially detrimental condition. Apparent movement was observed of the two downstream sections of pipe. It is recommended that these pipe joints be sealed to prevent any further intrusion of soil from the embankment or leakage of discharge water out of the conduit.

FIRST JOINT FROM DOWNSTREAM END OF  
PRINCIPAL SPILLWAY CONDUIT. DAYLIGHT  
CAN BE SEEN THROUGH JOINT.

- (3) An investigation should be made into the actual cause of the apparent piping voids in the vicinity of the inlet conduit.
- (4) The spillway conduit joints should be sealed and the two downstream pipe lengths should be monitored for possible horizontal movement.

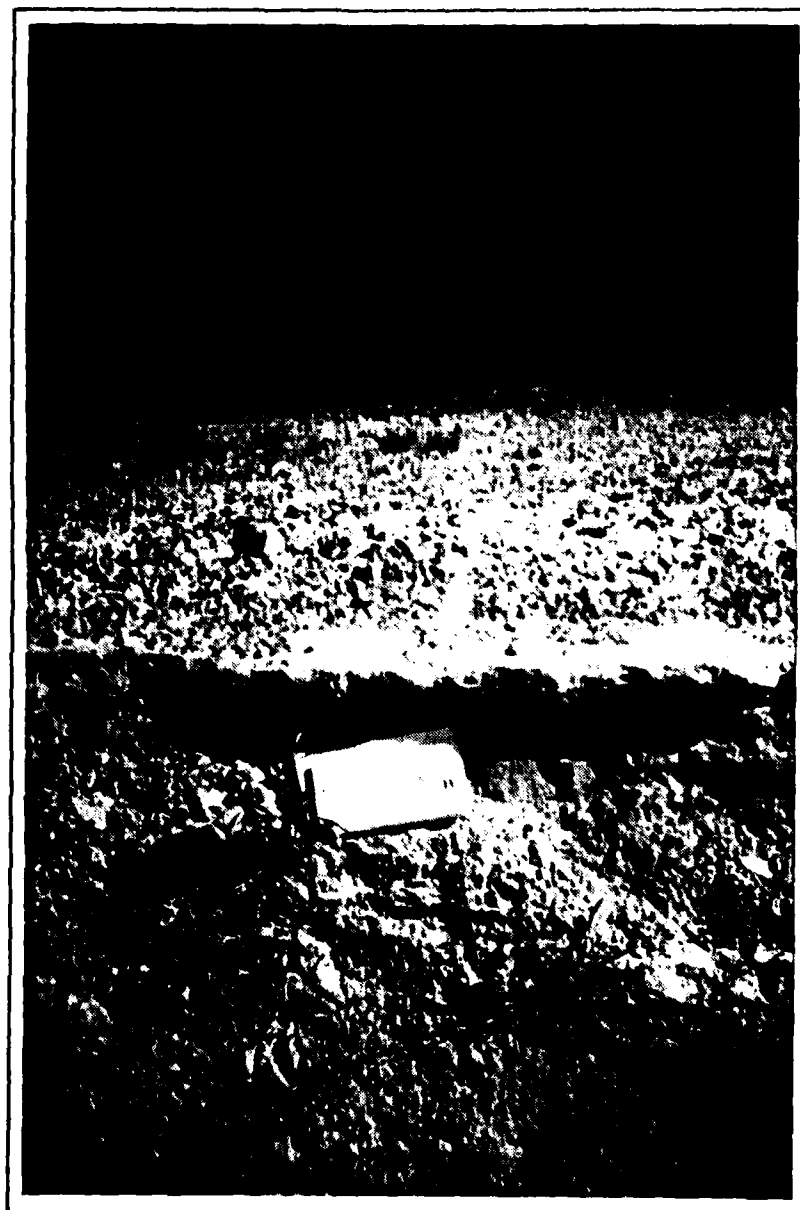
PHOTOGRAPH NO. 11

The erosion of the upstream face of the dam above the water level is judged to be a characteristic weakness of mixed in place soil-cement. Apparently, mixing of the cement with the soil did not produce a homogeneous mixture throughout the full lift thickness. As a result, less cement was blended with the soil at the bottom of each lift. Although deterioration appears not to have increased significantly since 1976, it is continuing and should be halted. Erosion was also noted around the inlet conduit at the right abutment. This could be a potentially detrimental condition and should be investigated further. The downstream embankment face is in good condition at the present time, except for the ruts and minor erosion around the inlet gate.

TYPICAL OF SOIL-CEMENT  
DETERIORATION ON UPSTREAM  
FACE.
